Magnetic Imaging of Ongoing Corrosion ACTIVITY in Aircraft Lap Joints

ELECTROMAGNETICS LABORATORY

DEPARTMENT OF PHYSICS AND ASTRONOMY, VANDERBILT UNIVERSITY

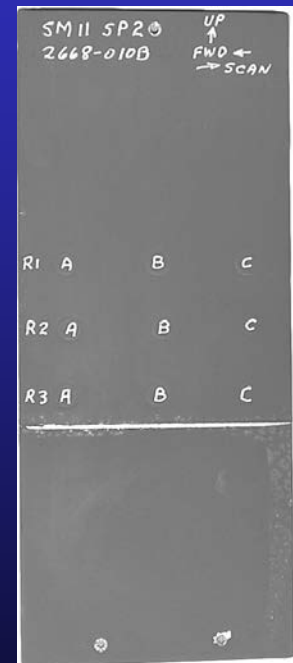
SQUID image of
corrosion activity

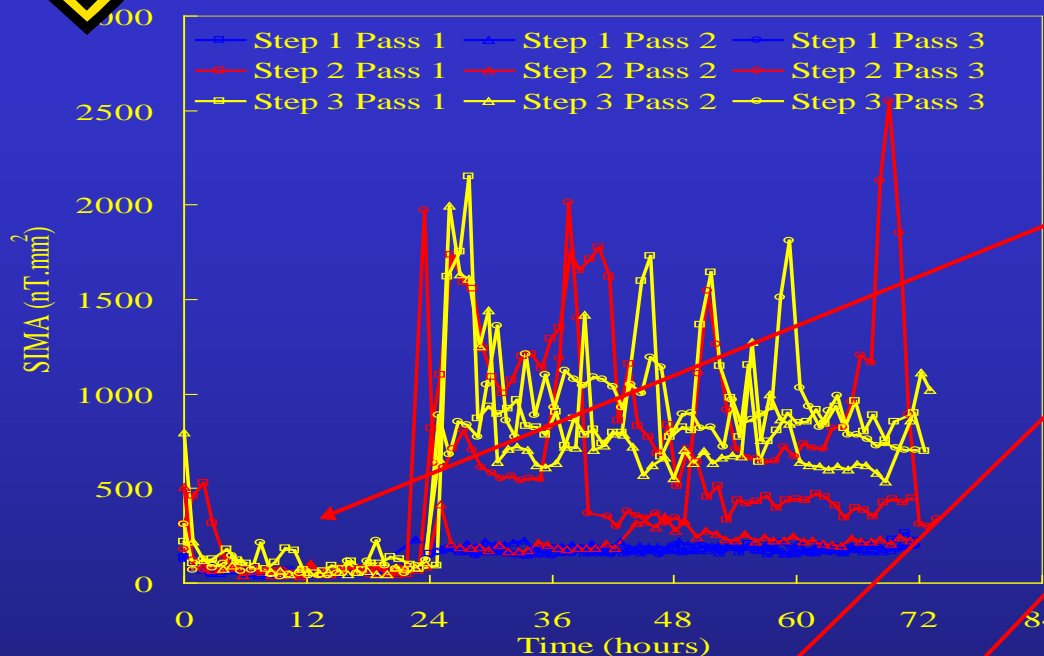
Summed magnetic activity versus time for old aircraft lap joints

- Reproducible dry background
- Low activity in 98% relative humidity air
- Distilled H_2O activates the chemistry within the lap joint
- 0.01 M chloride shows higher activity
- SQUIDs provide a unique research tool for studying hidden corrosion

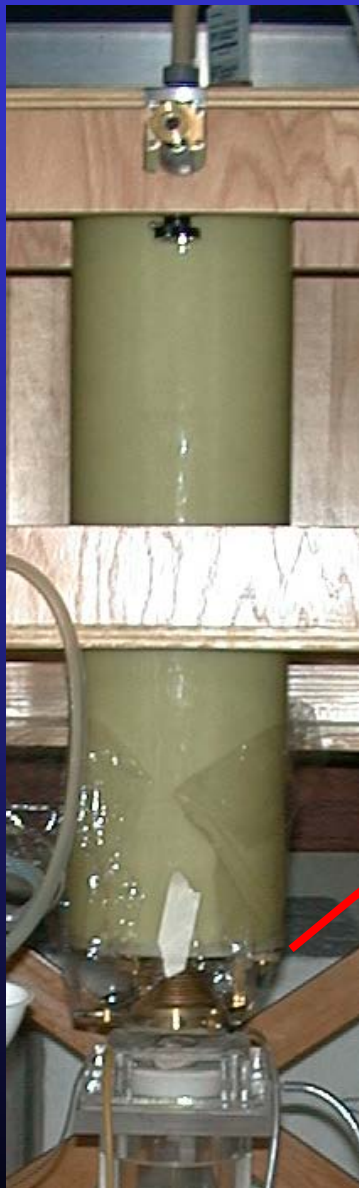
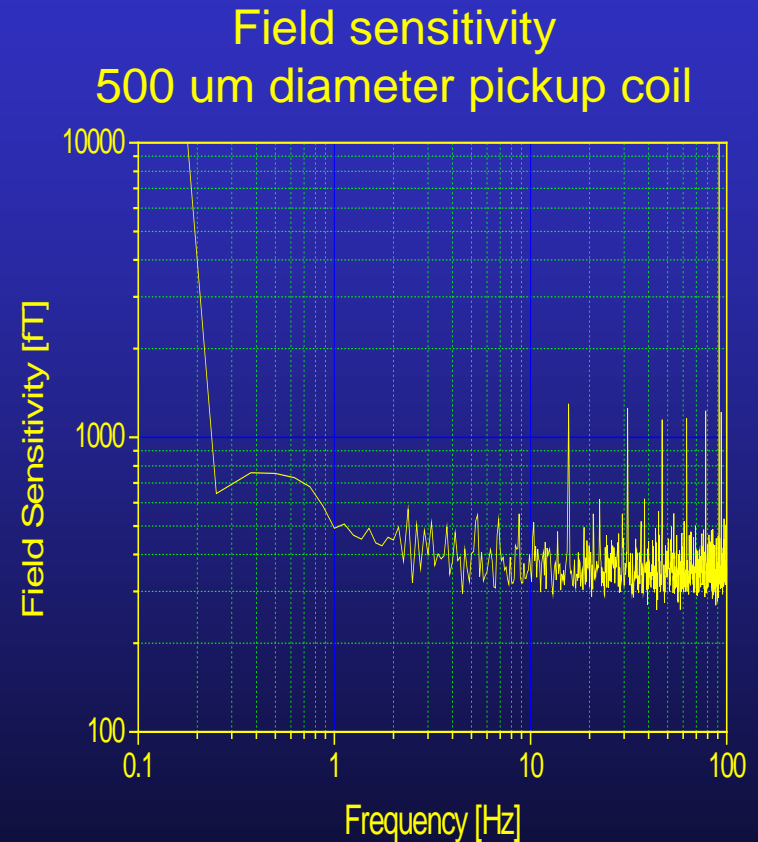
High Resolution LTS-SQUID Microscope for Room-Temperature Samples

4K-300K Sensor-Sample
Spacing < 100 μm

Field sensitivity
350 $\text{fT}/\text{Hz}^{-1/2}$ @ $f > 1\text{Hz}$
